DAMAGE OF REINFORCED CONCRETE BUILDINGS FROM THE 1985 MEXICO EARTHQUAKE

HAJIME UMEMURA¹
SHUNSUKE OTANI²

ABSTRACT

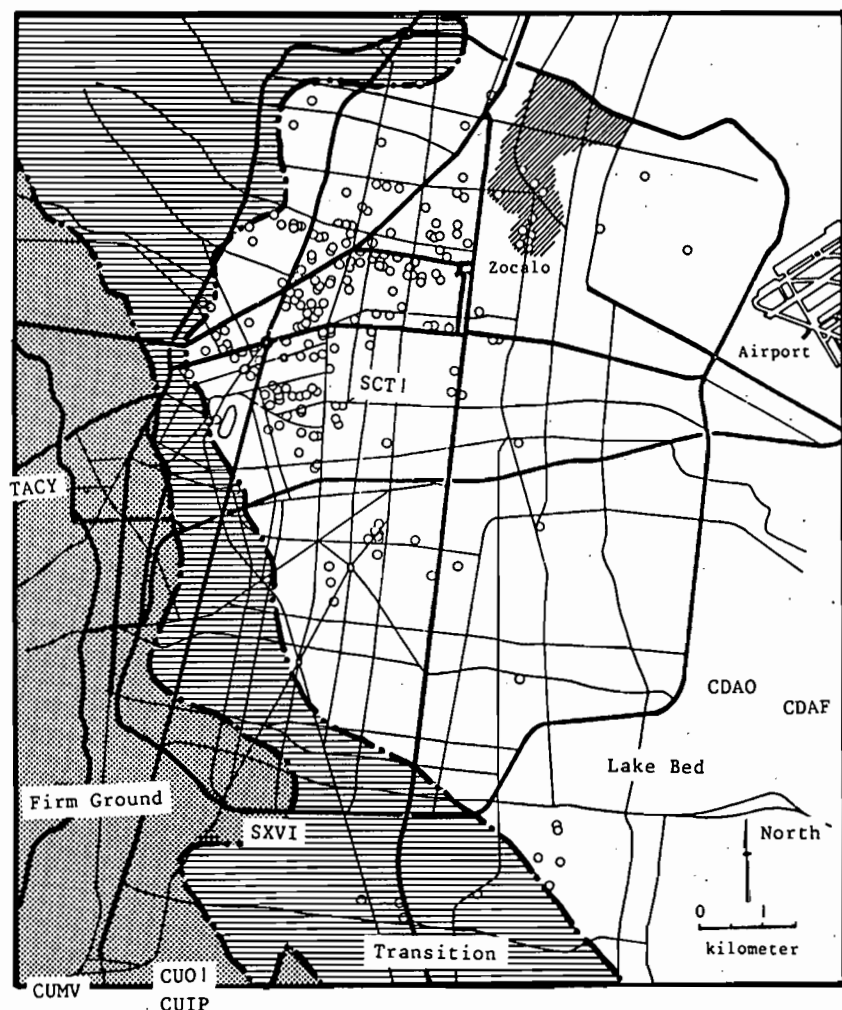
Fig. 1. Seismic Zoning, Severely Damaged Buildings, and Earthquake Recording Stations.

An investigation (8) immediately after the earthquake reported severe damage in the lake bed zone (Fig. 1). Therefore, the AIJ investigation team decided to concentrate the efforts in selected areas in the lake bed zone within the limit of time and man power. A group of two to three experien-

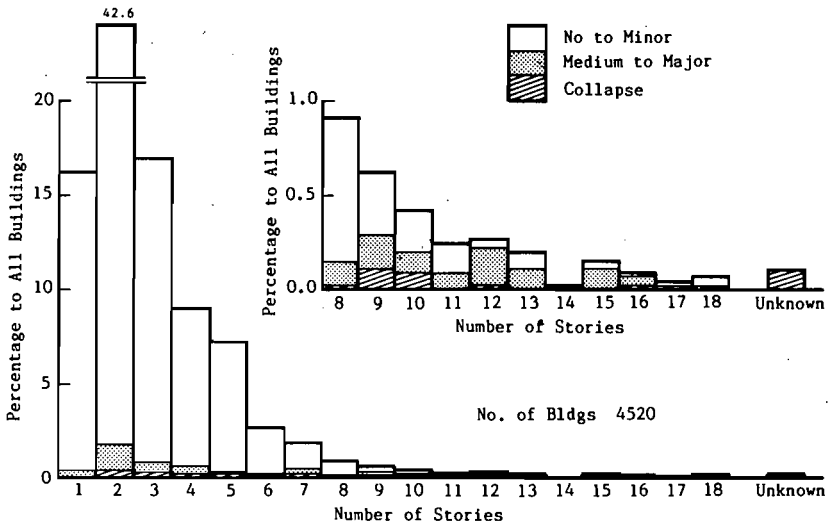
Fig. 3. Summary of Damage Inventory Survey.

No to light damage was observed in 82 percent of the all buildings, and in 85.2 percent of the buildings of less than 6 stories. The collapse occurred in 1.8 percent of the buildings surveyed, and in 9.0 percent of the buildings of more than five stories. Note the increase in the percentage of damaged buildings with the number of stories.

The damage was relatively light in low-rise buildings. For a total of 1,245 masonry buildings surveyed, the average damage ratio was 4.2 percent.
